From: Stephen Best
To: Flock Safety Support
Cc: brendon.norton@flocksafety.com; Tee Jane Teh; libby.landers@flocksafety.com; Eligio Lara; Daniel Cohen; jake.sherman@flocksafety.com; Michael Balcorta; Stephen Best
Subject: RE: Cam 086 "SB Bradley (north of Hancock)" still fail to read
Date: Thursday, May 30, 2024 9:33:22 AM

---------- Original Message ----------
From: Stephen Best [sbest@cityofsantamaria.org]
Sent: 5/30/2024, 9:07 AM
To: libby.landers@flocksafety.com; support@flocksafety.com; jake.sherman@flocksafety.com; brendon.norton@flocksafety.com
Cc: elara@cityofsantamaria.org; dcohen@cityofsantamaria.org; sbest@cityofsantamaria.org; mbalcorta@cityofsantamaria.org; tteh@cityofsantamaria.org
Subject: Cam 086 "SB Bradley (north of Hancock)" still fail to read

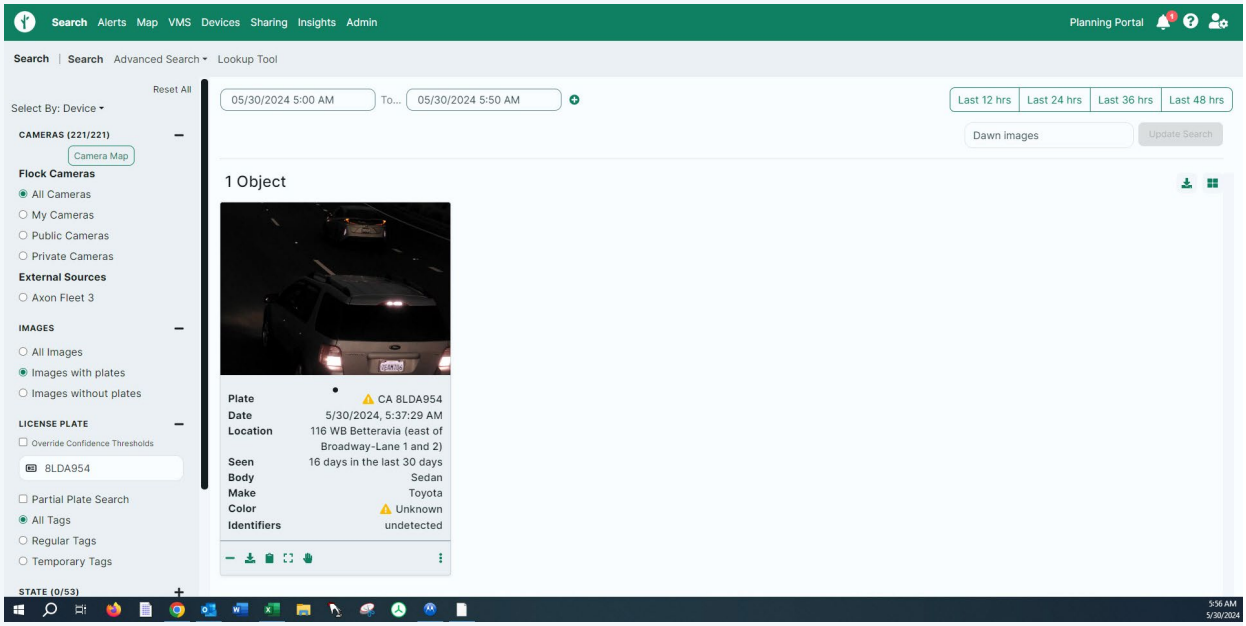
Flock Safety Support,
Camera “086 SB Bradley (north of Hancock)” has been having problems reading plates at night.
You serviced the camera yesterday 05-29-24.
This morning (dawn…not really dark at all), I drove past the camera at 05:35:15 Hrs. in the #1 lane and the camera failed to record my plate (or my vehicle).
It DID record the pickup truck which was in the #2 lane behind me about 100 yards (about 2 seconds later).
Attached is the documentation.
Please continue to work on this camera.
Thank you.
